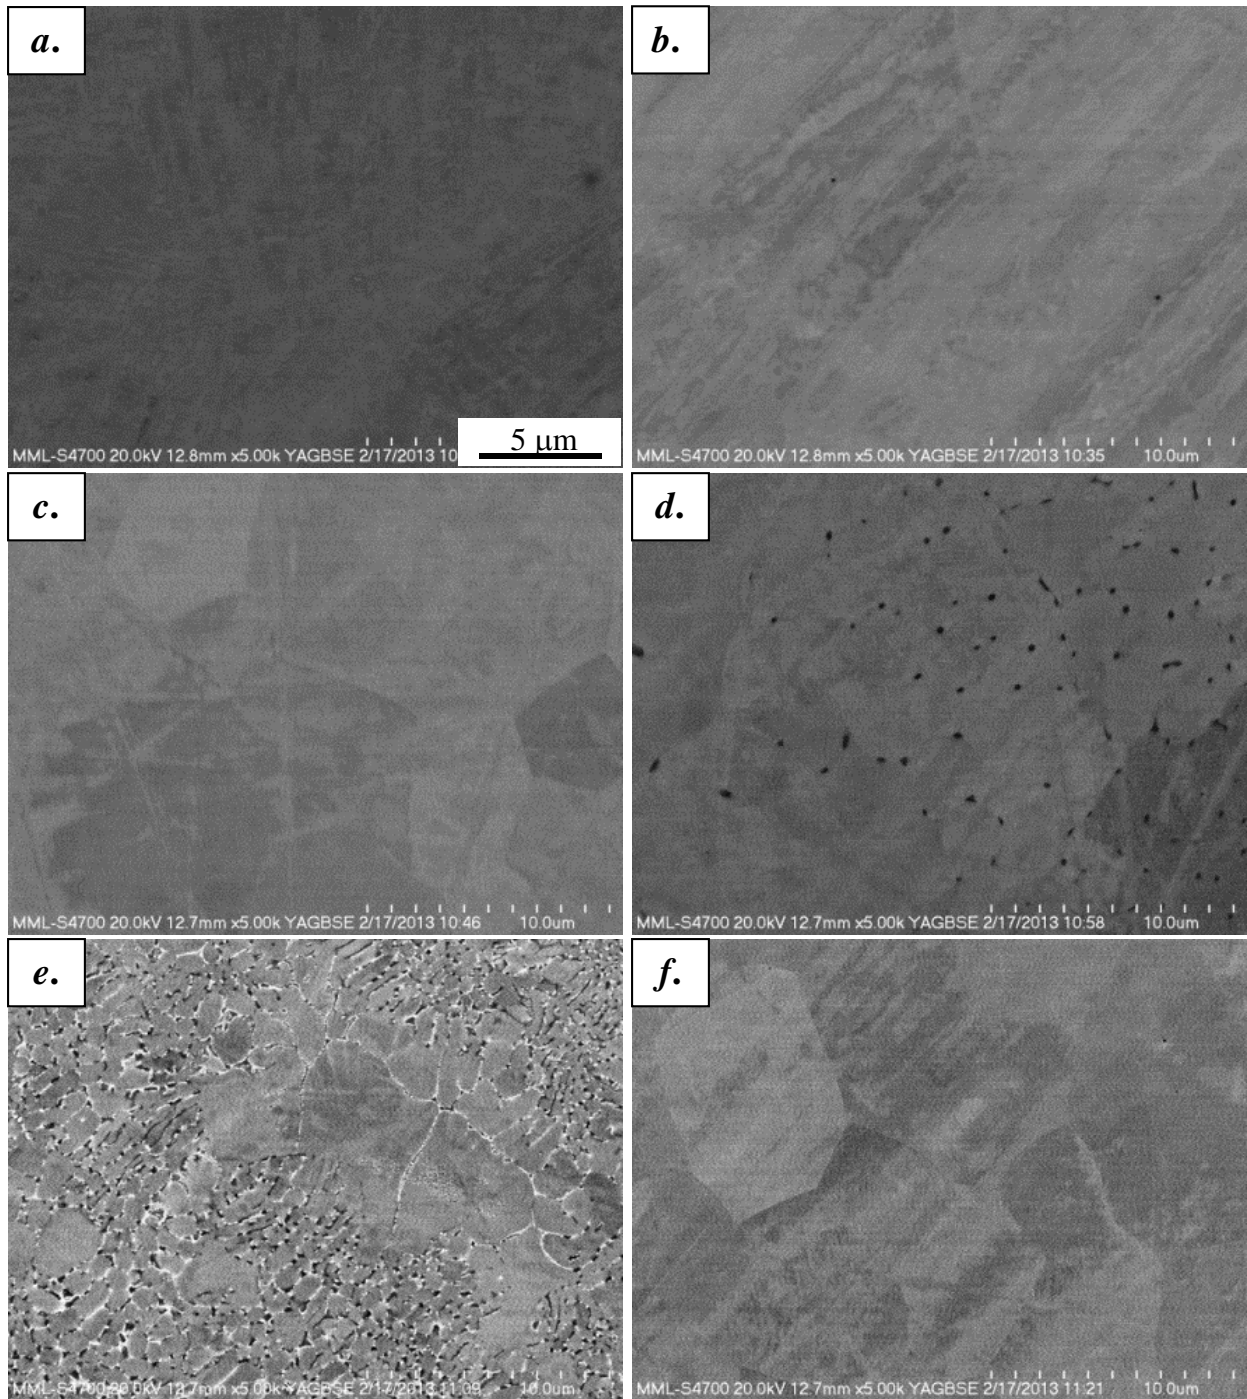
Figure 1: BSE micrographs of the as-spun ribbons: *a*) L01 (Co-10W), *b*) L02 (Co-7.5W-10Al), *c*) L03 (Co-10W-8.25Al), *d*) L04 (Co-7.5W-12.5Al), *e*) L05 (Co-15W-12Al), and *f*) L06 (Co-10W-9.5Al). Small precipitates of B2 (black) are found in *d*) (L04); while both B2 and μ (white) are found in the as-spun microstructure of L05 in *e*). The scale bar in *a*) is representative of all images (i.e. the magnifications are the same).
